**ROUND VALLEY NORTH DAM**

**ROUND VALLEY DYKE**

**PHASE I INSPECTION REPORT**

**NATIONAL DAM SAFETY PROGRAM**

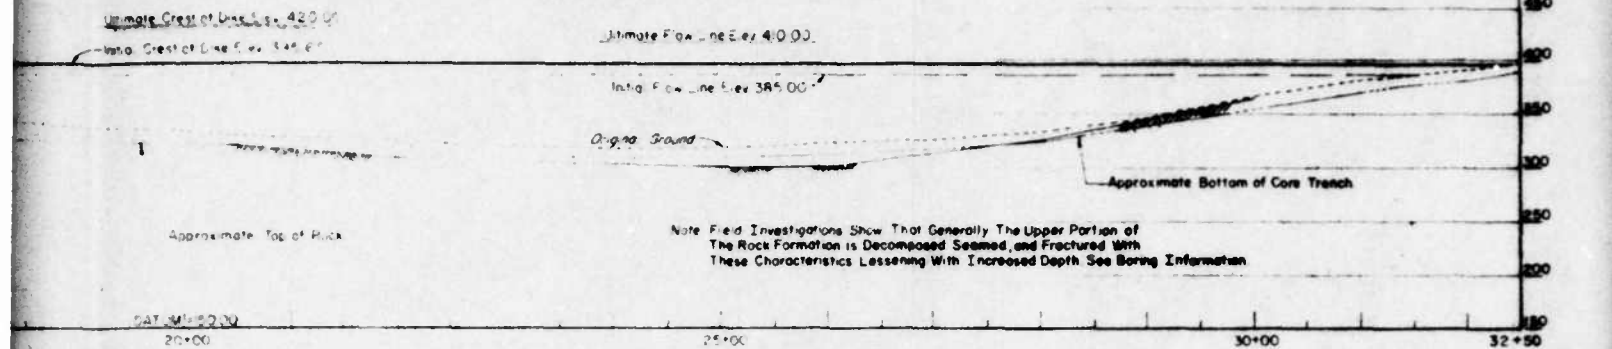
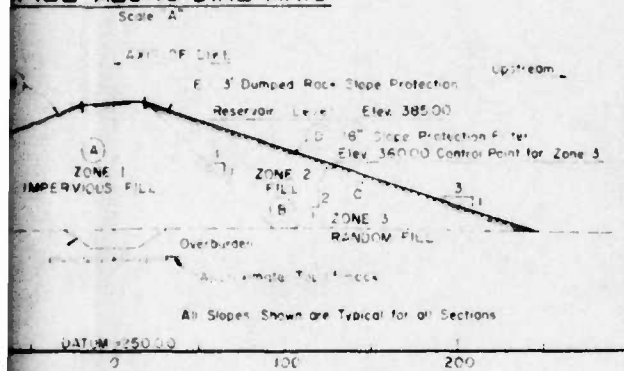
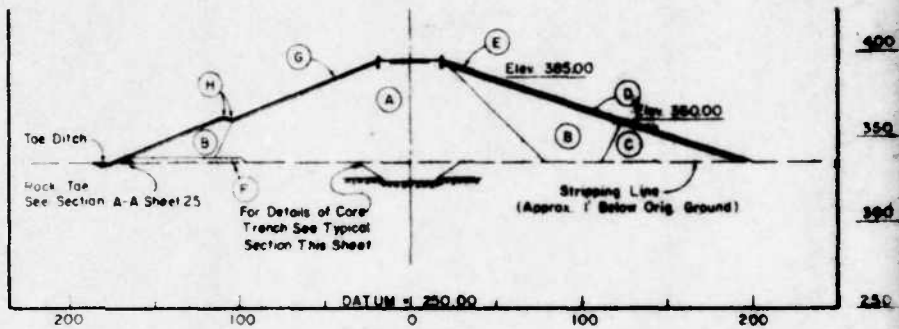
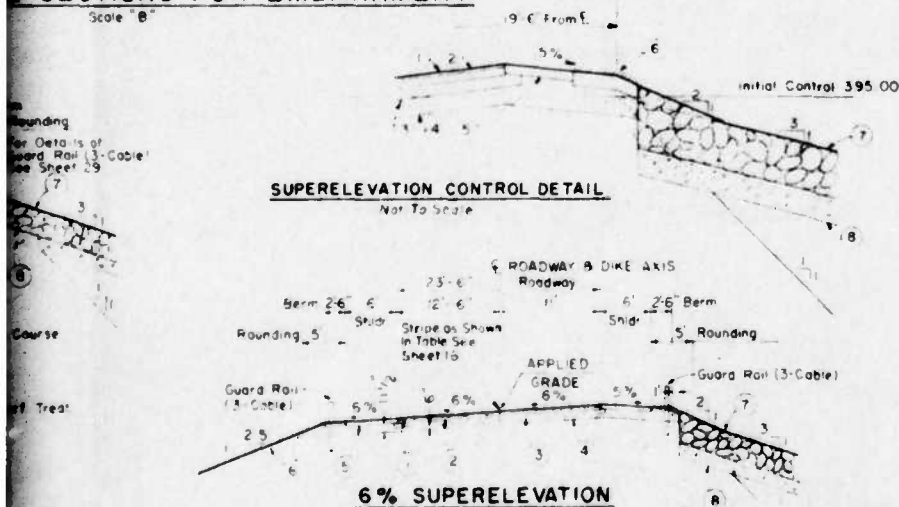
## FIGURE 8

The Dike has a maximum height of about 78 feet and is approximately 2,335 feet long. The top width is 40 feet, and consists of a 22-foot wide macadam roadway with 6-foot wide macadam shoulders and grassed berms on each side. The upstream slope of the Dike is 3:1 (horizontal:vertical); the downstream slope is 2.5:1 and is provided with a gutter berm and a toe ditch. Refer to Figure 8 for details of Dike sections.
